Combe Fen Restoration Report

David Morris

Morris, D. 2024. Combe Fen Restoration Report. Freshwater Habitats Trust, Oxford.

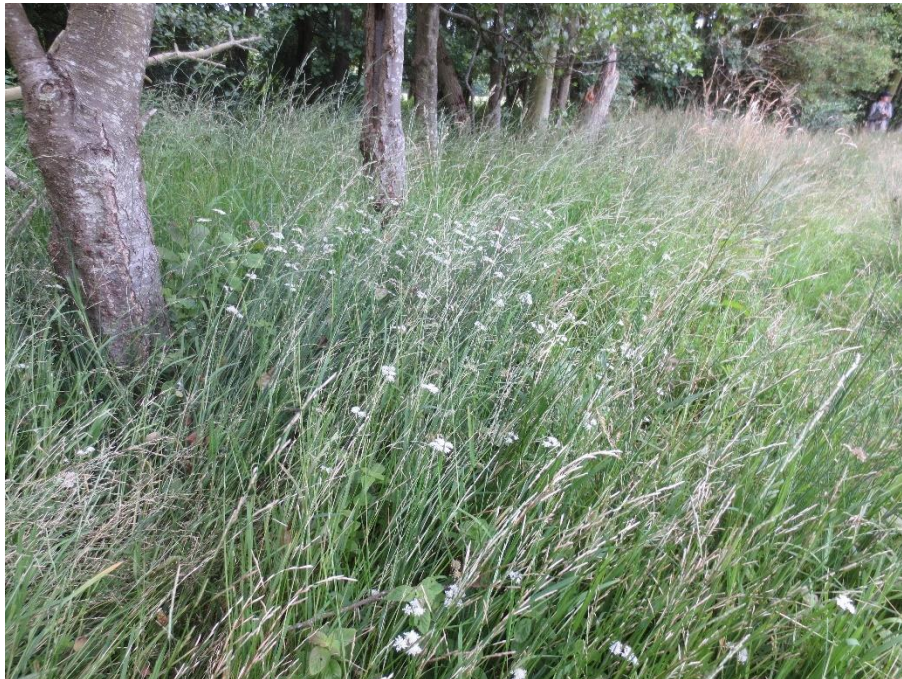
Figure 2. Population of Tubular Water-dropwort (white flowers in foreground) photographed during survey in 2016. J.A. Webb.

Tubular Water-dropwort is a priority species. It was last seen at the site in 2016 during a LWS survey, but the record does not specify where. One of the surveyors, Dr Judy Webb, shared a photograph of the population taken during the survey (Figure 2).

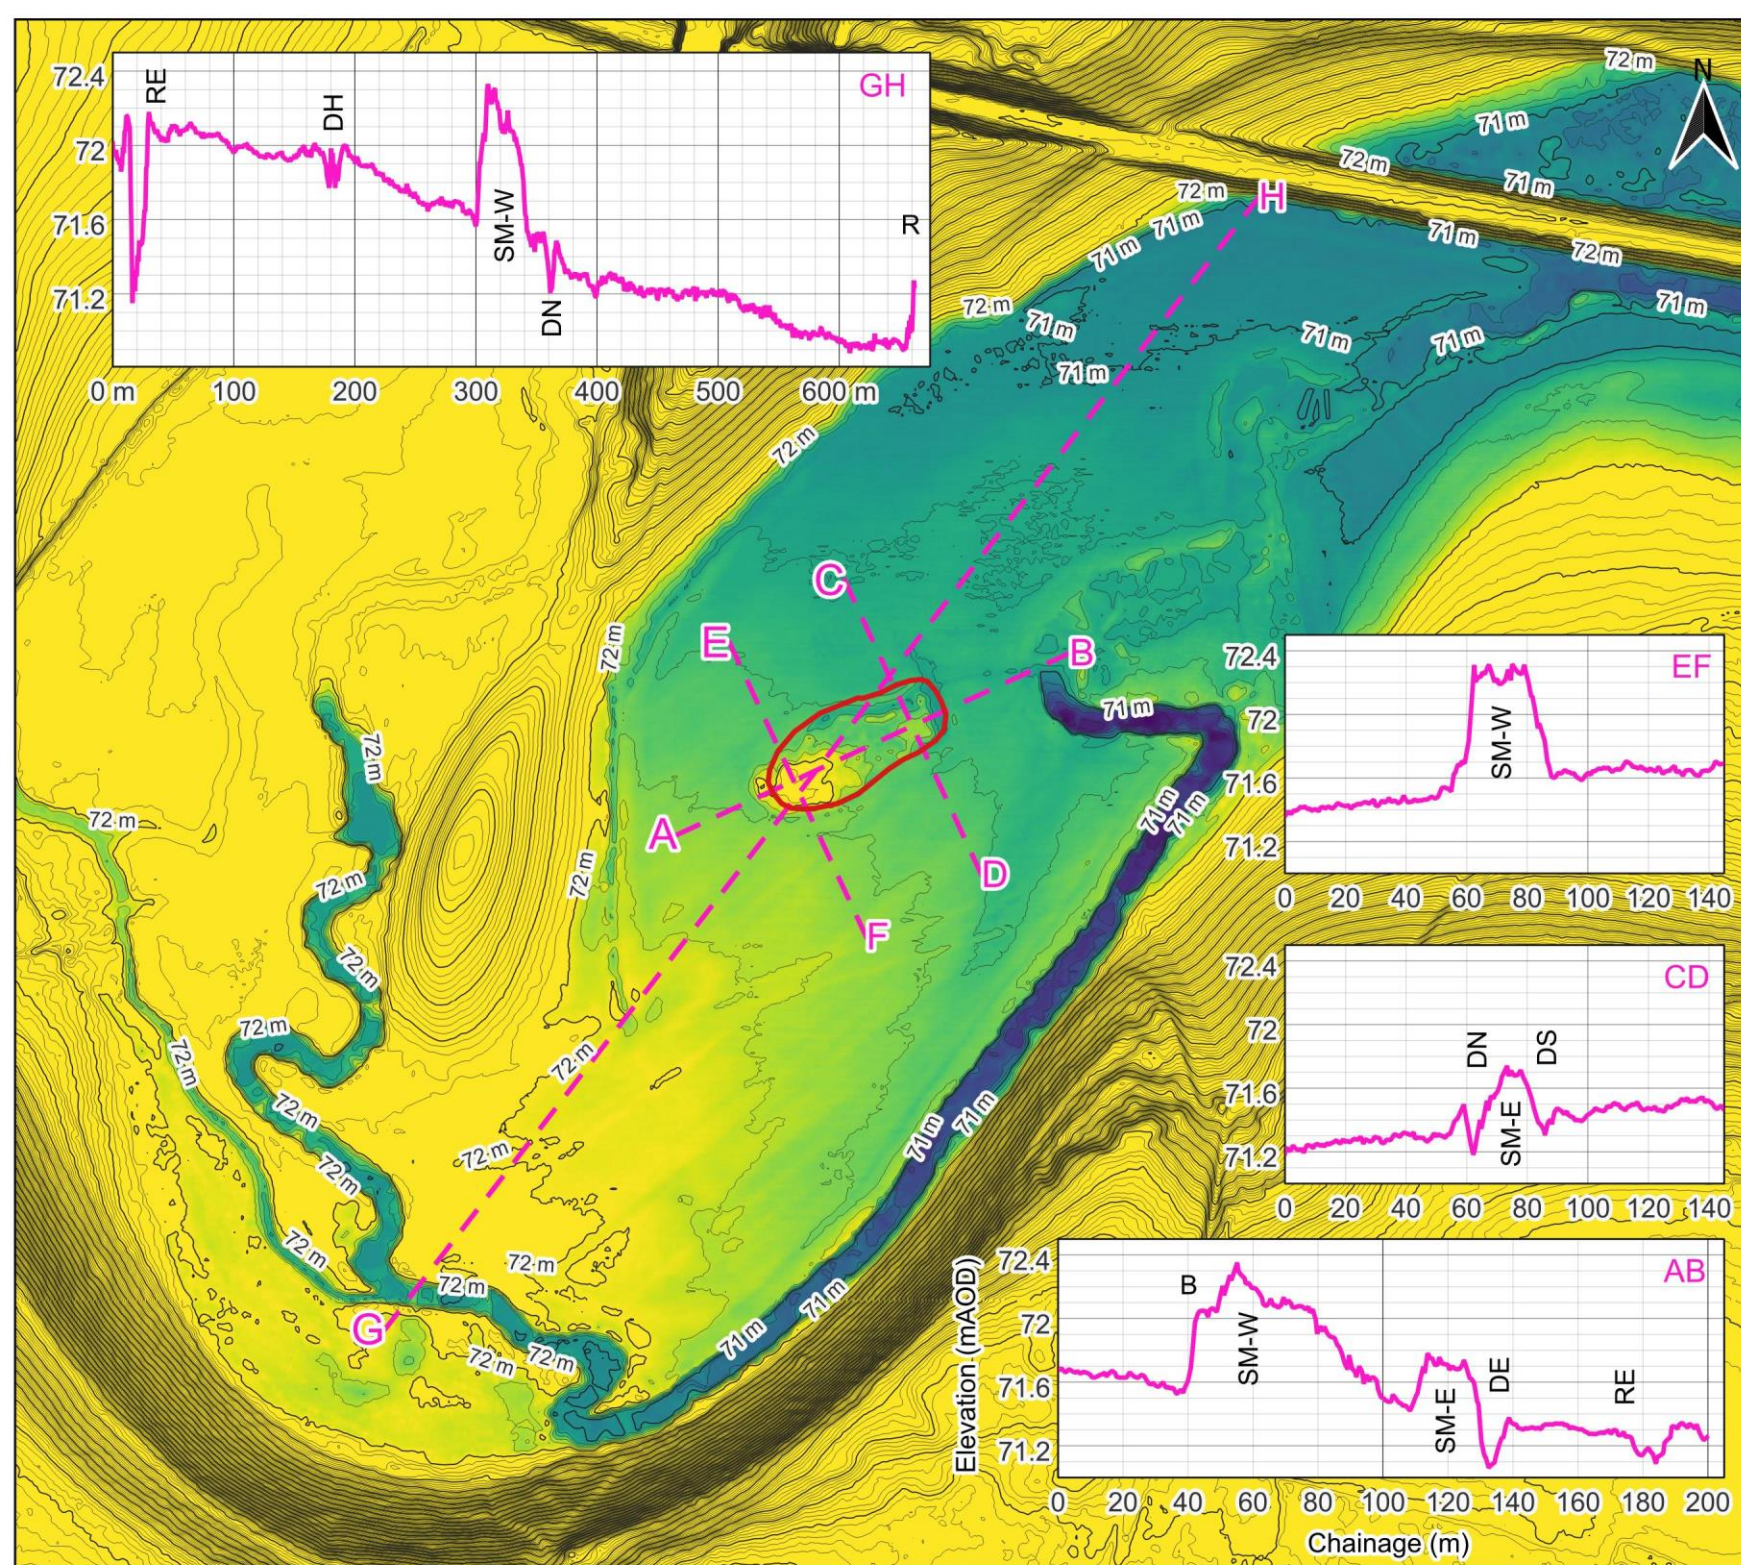
Figure 4.
Topography of
Combe Fen

There is a low embankment around the western end of the site (marked 'B' in elevation section AB Figure 4), presumed to be spoil dumped against the slope of the mound from the excavation of a shallow ditch around the western side of the mound. There is also a low embankment on the inside of the ditch on the northern side of the site.

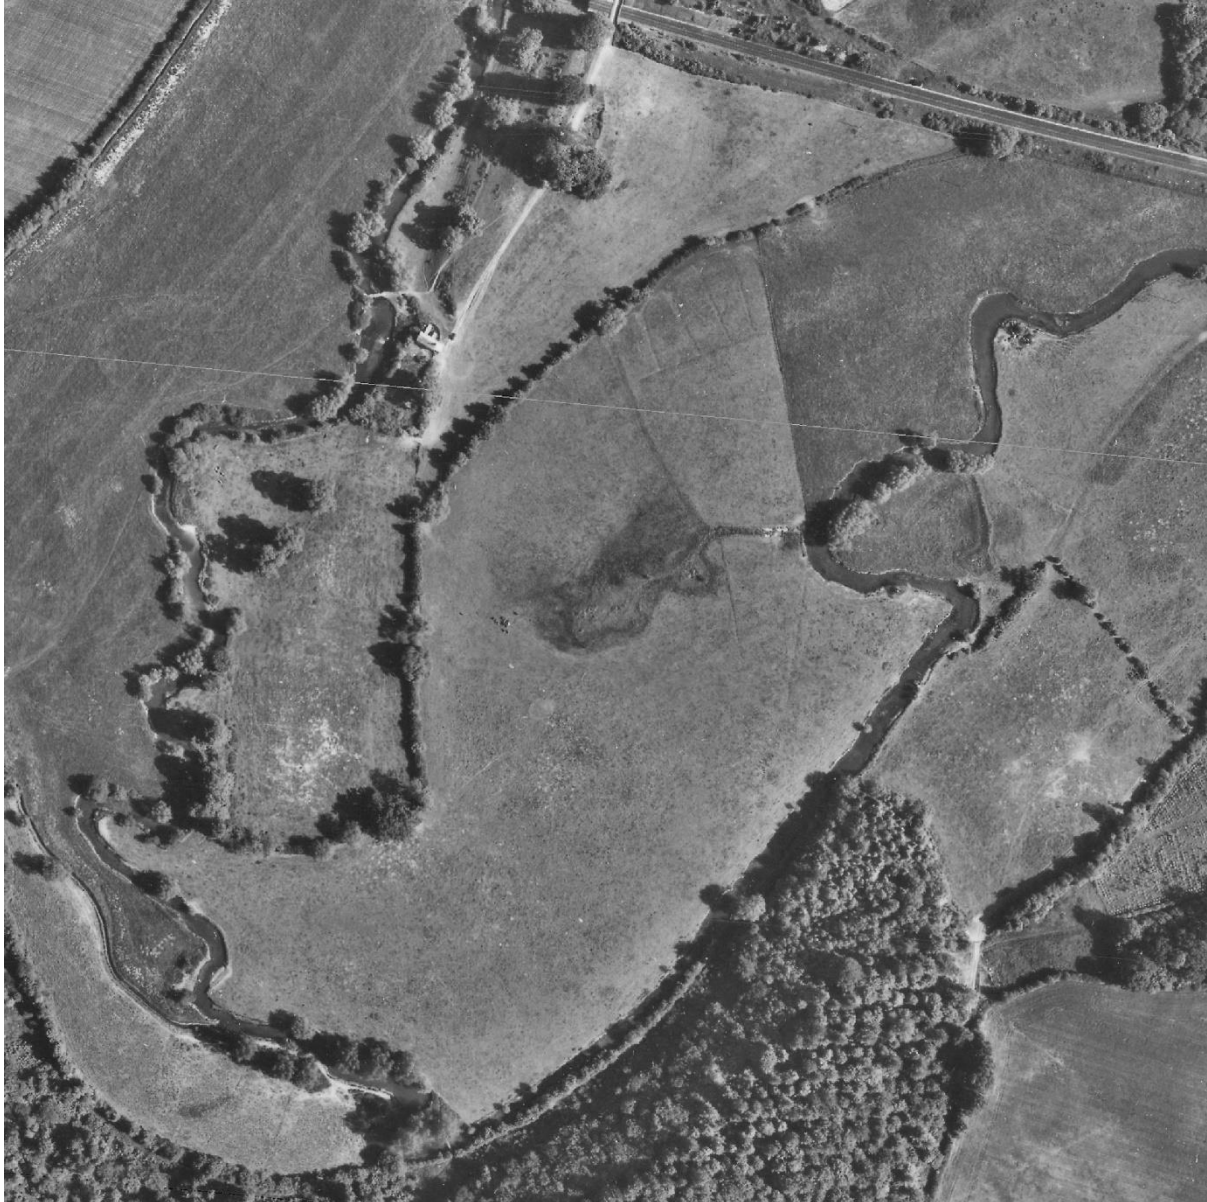
Figure A1.1. Extract at 1:3,000 scale from Fairey aerial survey of 1961. Copyright Oxfordshire History Centre.

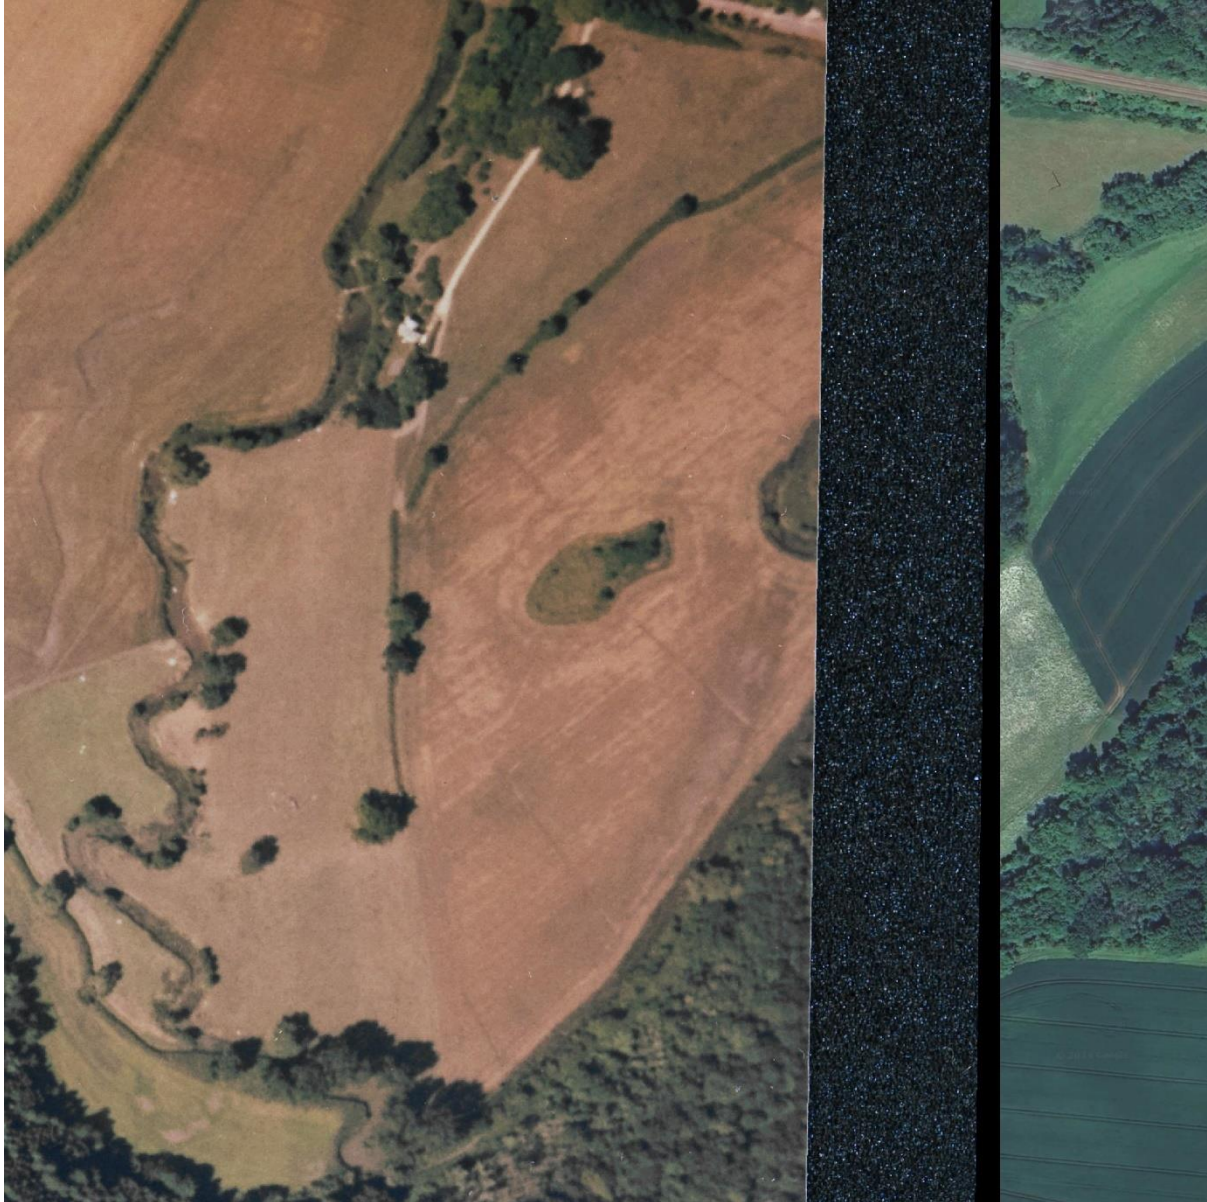
Figure A1.2. Extract at 1:3,000 scale from Astral aerial survey of 1981. This frame of the survey does not cover the whole field around Combe Fen. Modern Google Satellite image shown in area not covered. Copyright Oxfordshire History Centre.

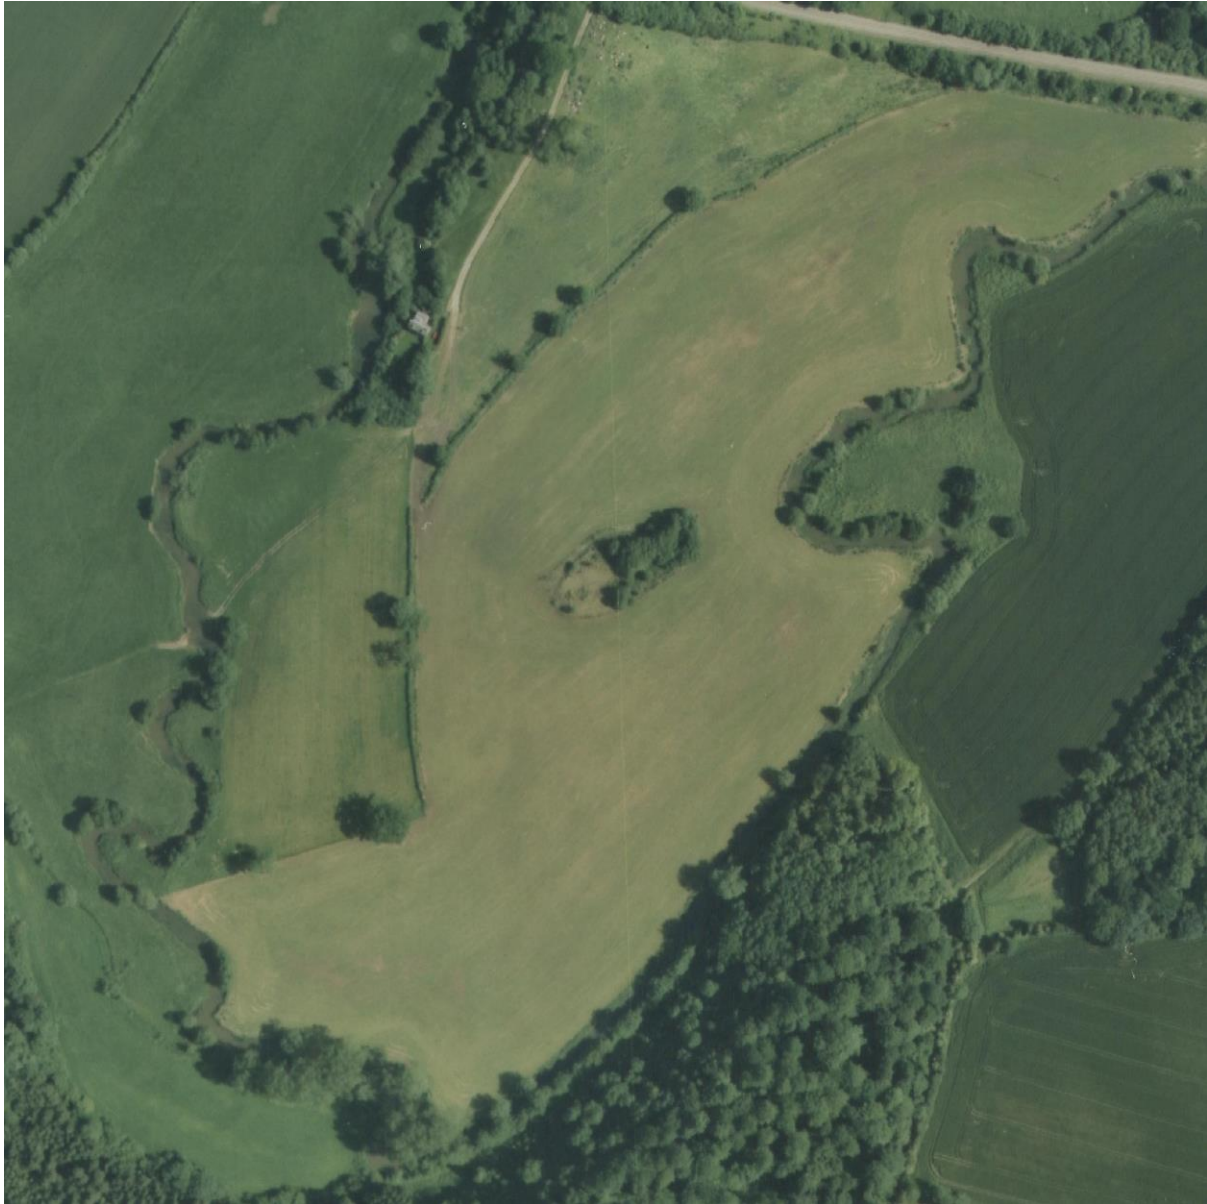
Figure A1.3. Extract at 1:3,000 scale from Geonex aerial survey of 1991. Copyright Oxfordshire History Centre.

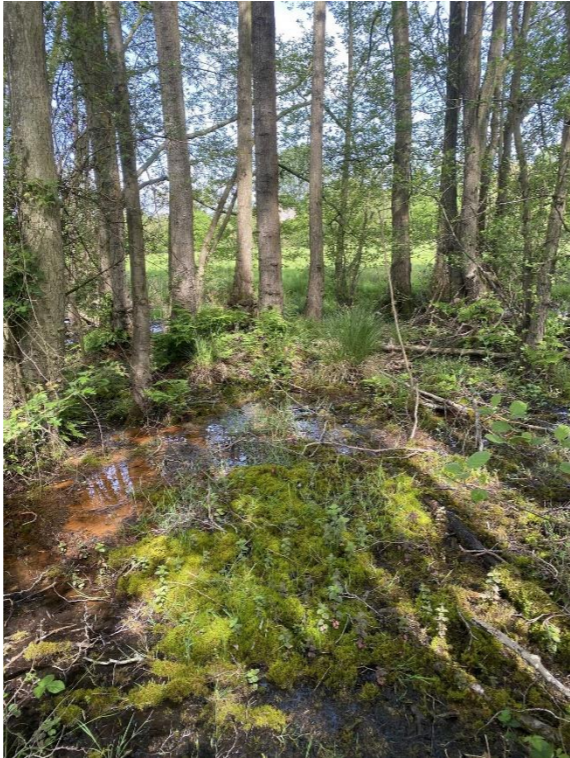
| No. | Description | Photograph(s) |
|---|--|--|
| 1 | <p><i>Alnus glutinosa</i> woodland over top of eastern spring mound, with open field layer around pools and runnels, comprising scattered <i>Carex paniculata</i> and <i>Dryopteris dilatata</i> tussocks, and mats of <i>Palustriella commutata</i>. 17/05/2024</p> | |

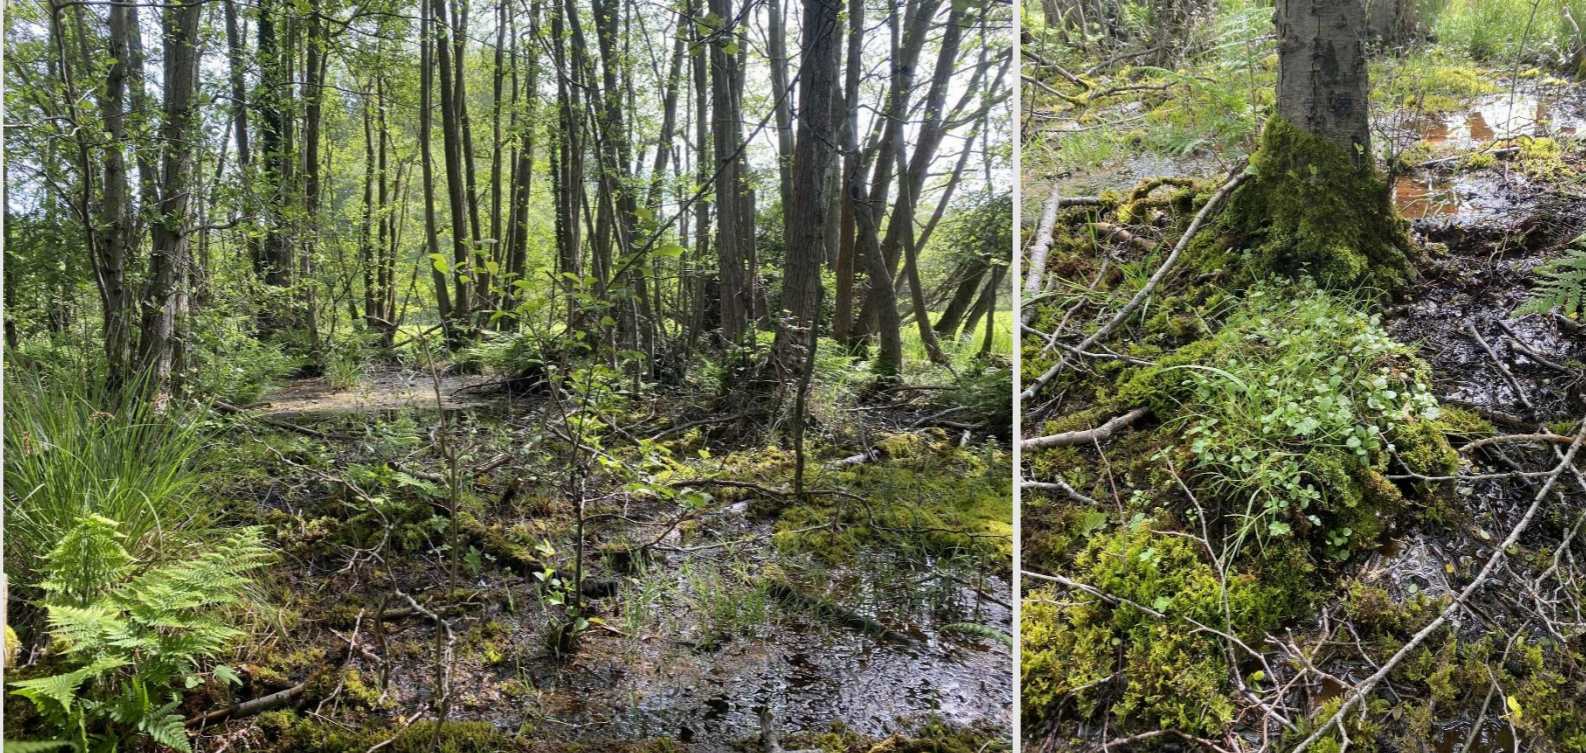
| No. | Description | Photograph(s) |
|---|--|--|
| 2 | <p>Flow west from spring in shallow mossy runnels. Patches of <i>Valeriana dioica</i> frequent around tree bases and increasing west from here. 17/05/2024</p> | |

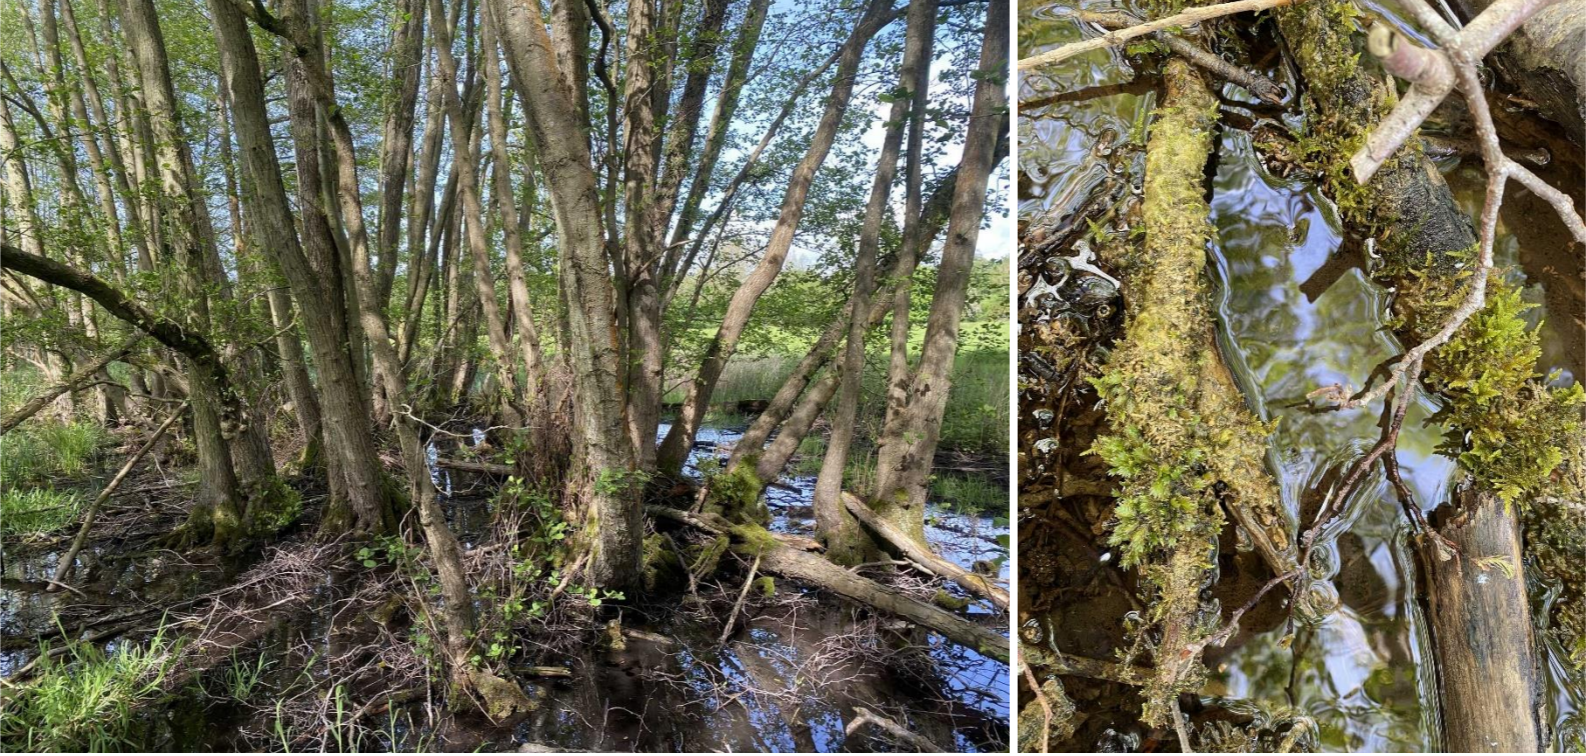
| No. | Description | Photograph(s) |
|---|---|---|
| 3 | Water flowing around north and south side of narrow central area of young <i>Alnus</i> trees, forming pools and runnels among roots, with abundant brown mosses and tufa. Second photo shows <i>Fissidens adianthoides</i> (left) and <i>Palustriella commutata</i> (right). 17/05/2024 | |

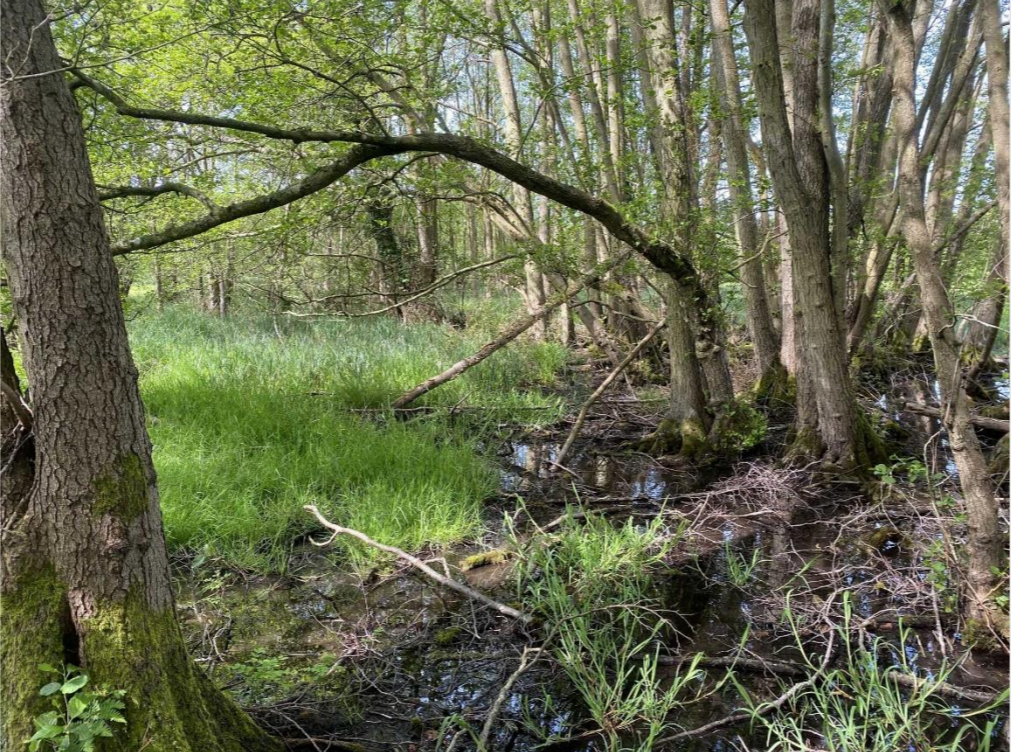
| No. | Description | Photograph(s) |
|---|---|---|
| 4 | Flow accumulation on south side of central area, dominated by <i>Glyceria notata</i> . 17/05/2024 | |

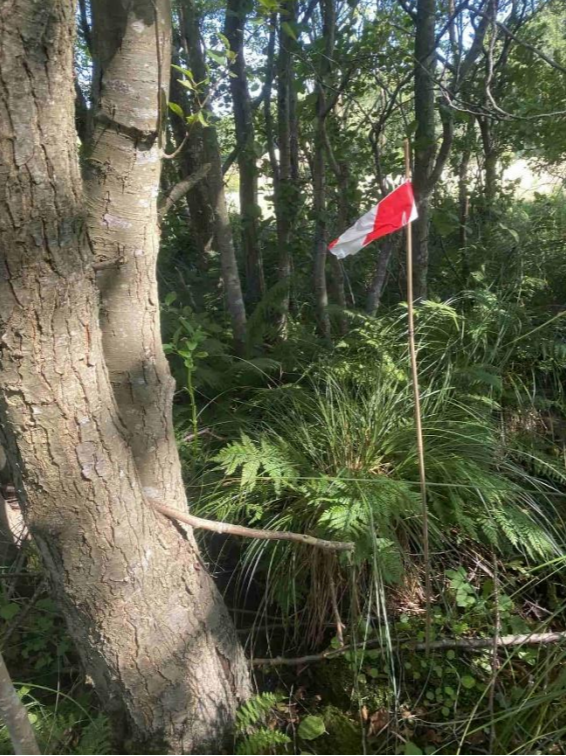
| No. | Description | Photograph(s) |
|---|---|---|
| 7 | <i>Hydrocotyle vulgaris</i> growing on dead <i>Carex paniculata</i> tussocks. Marked 16/08/2024. | |

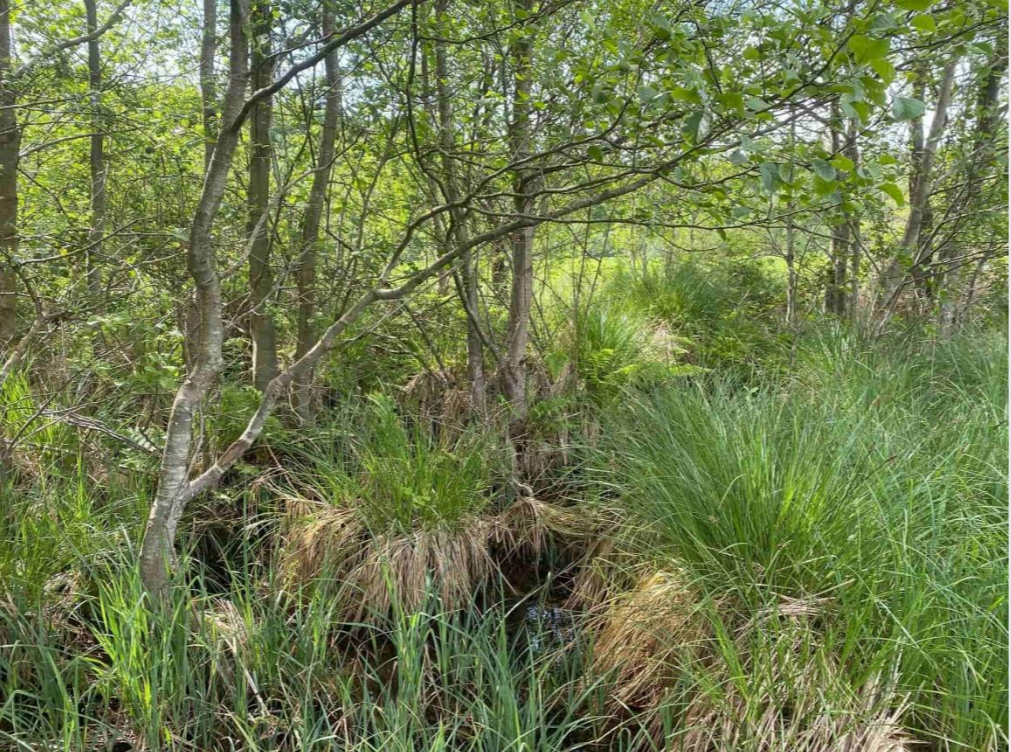
| No. | Description | Photograph(s) |
|---|---|---|
| 8 | Young stand of <i>Alnus</i> around western spring, with abundant <i>Carex paniculata</i> . 17/05/2024 | |

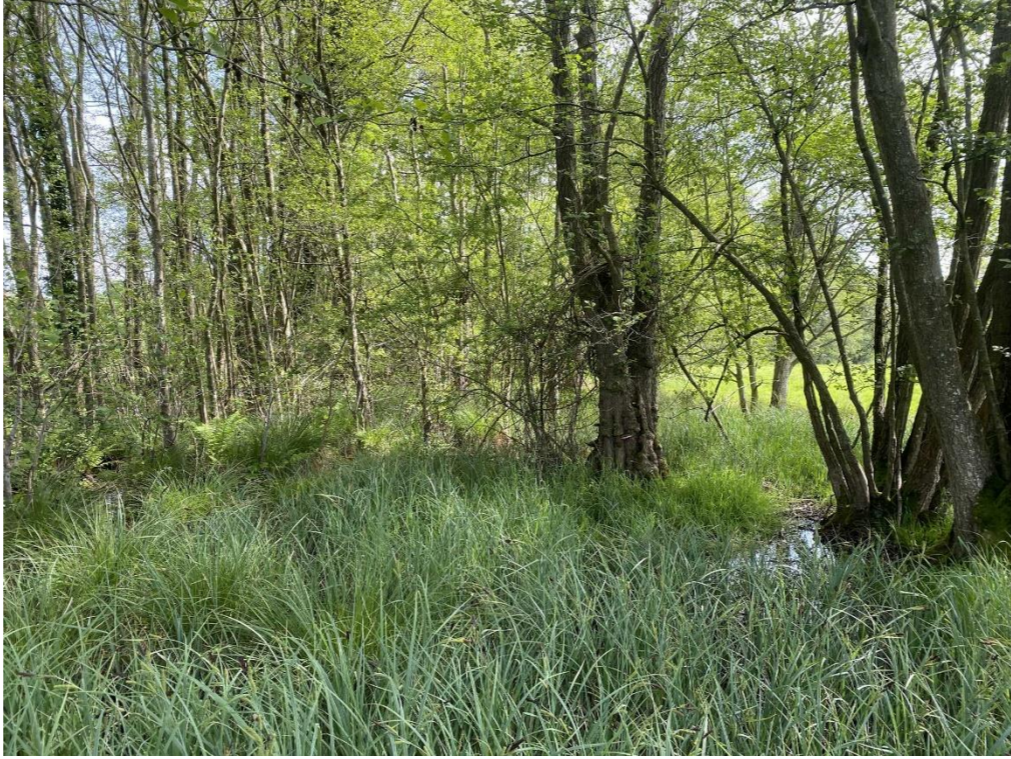
| No. | Description | Photograph(s) |
|---|--|---|
| 9 | Area of deeper water accumulation and loose sediment, with unstable <i>Carex paniculata</i> tussocks. 17/05/2024 | |

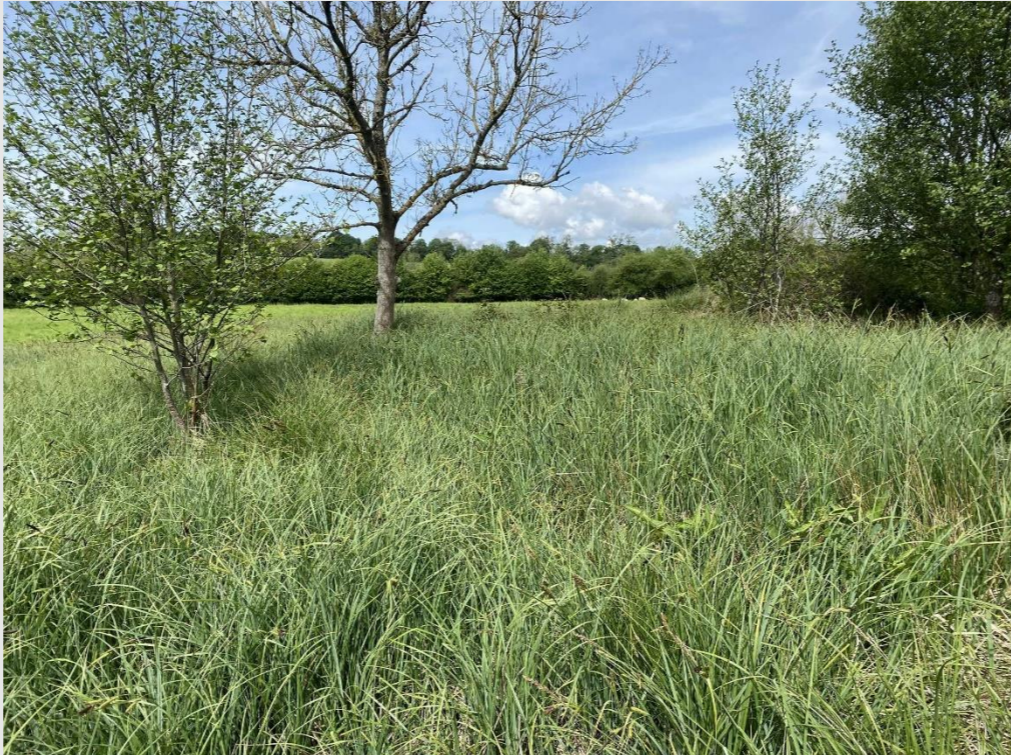
| No. | Description | Photograph(s) |
|---|--|---|
| 10 | <i>Carex acutiformis</i> dominated fen at open, western end of site. 17/05/2024 | |

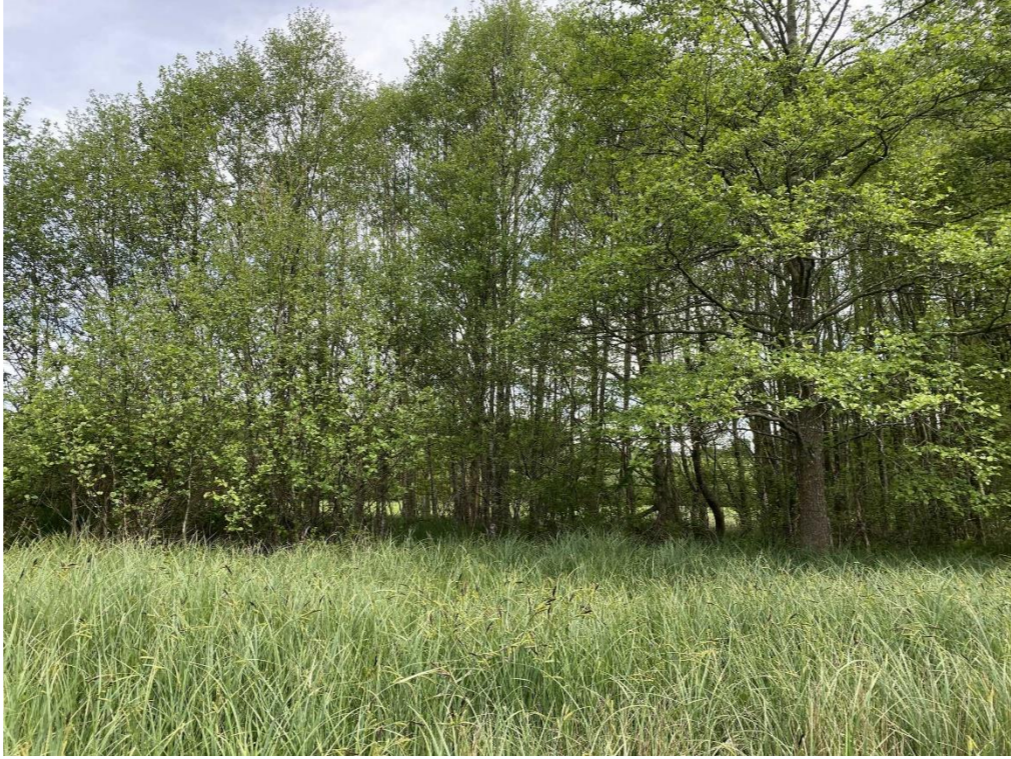
| No. | Description | Photograph(s) |
|---|---|---|
| 11 | Young stand of <i>Alnus</i> over western spring. 17/05/2024 | |

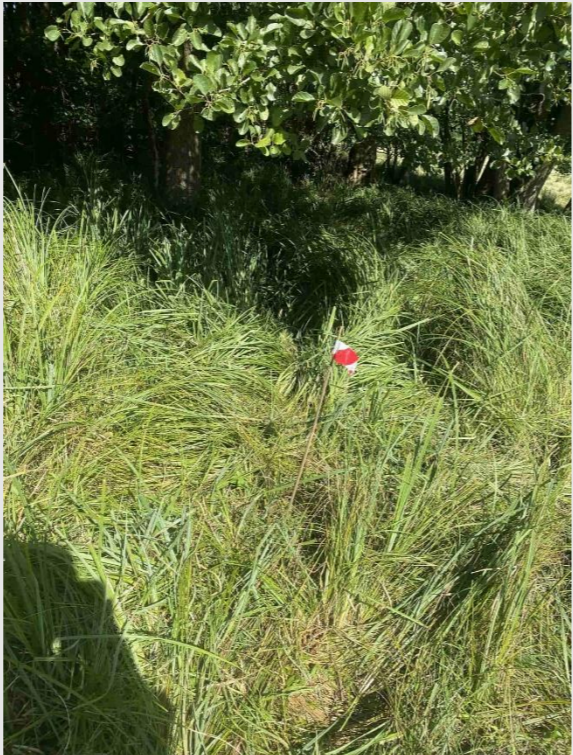
| No. | Description | Photograph(s) |
|---|---|---|
| 12 | Compared to rest of site, small area of more species-rich fen, with <i>Carex panicea</i> , <i>Galium uliginosum</i> , <i>Succisa pratensis</i> and <i>Valeriana dioica</i> . Marked 16/08/2024. | |

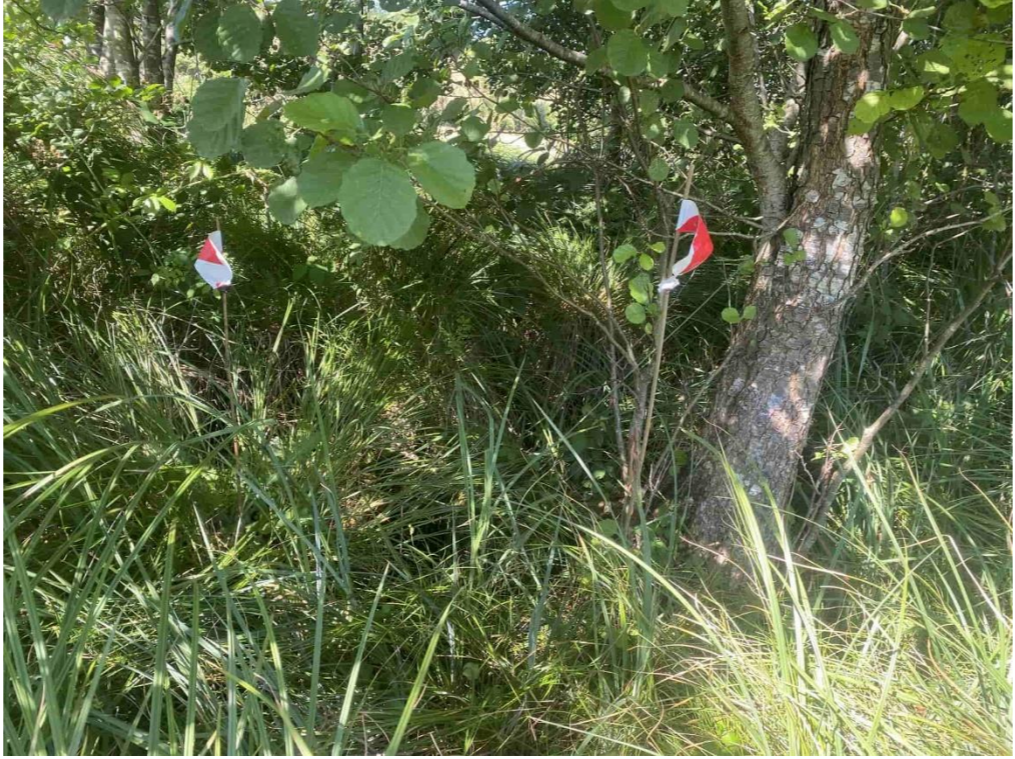
| No. | Description | Photograph(s) |
|---|--|---|
| 13 | <p><i>Hydrocotyle vulgaris</i> growing on tree bases, old tussocks and dead wood at edge of trees. One plant of <i>Succisa pratensis</i>. Marked 16/08/2024.</p> | |

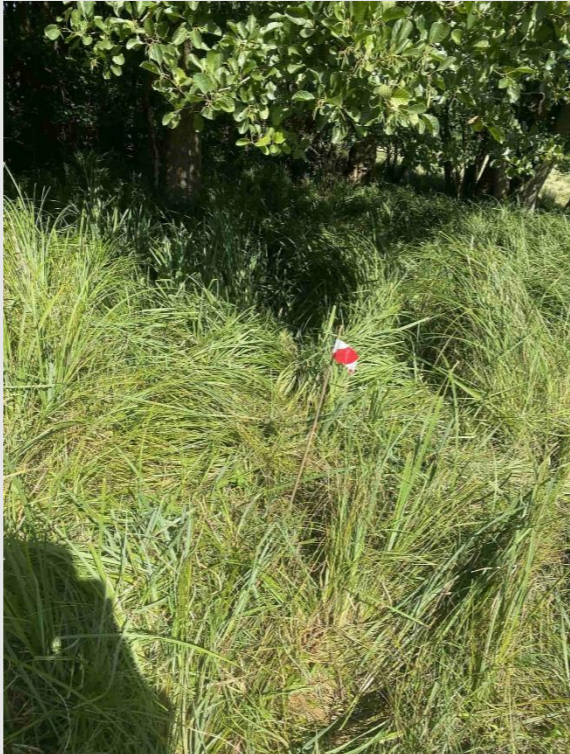
| No. | Description | Photograph(s) |
|---|--|---|
| 14 | <p>One plant of <i>Succisa pratensis</i> at edge of <i>Alnus</i> and <i>Rosa</i> scrub. Marked 16/08/2024.</p> | |

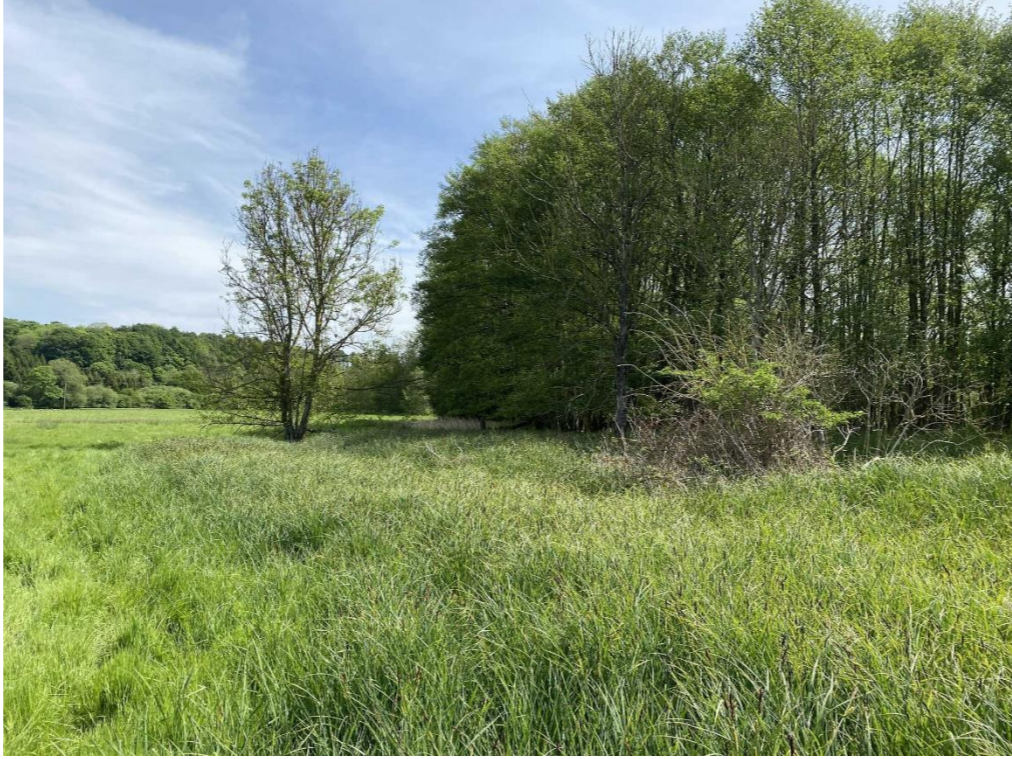
| No. | Description | Photograph(s) |
|---|--|---|
| 17 | <i>Carex acutiformis</i> fen and pasture edge, along north side of site. 17/05/2024 | |

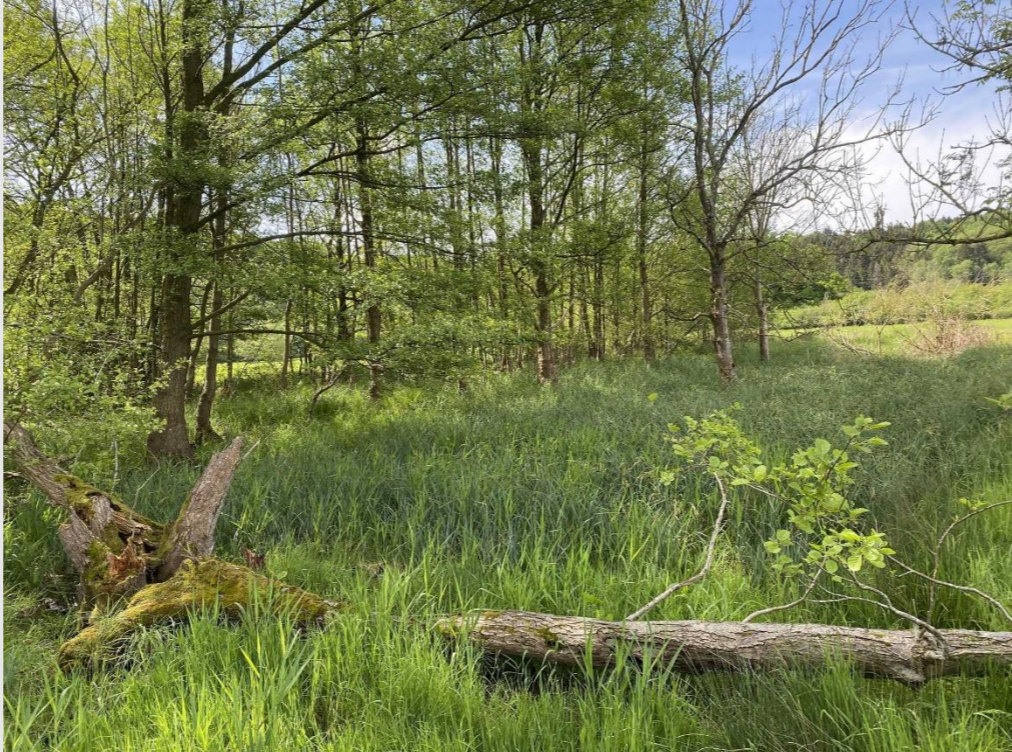
| No. | Description | Photograph(s) |
|---|--|---|
| 18 | <i>Carex acutiformis</i> and <i>C. riparia</i> dominated fen along north side of site. Area in foreground where water accumulates dominated by <i>Glyceria notata</i> . 17/05/2024 | |

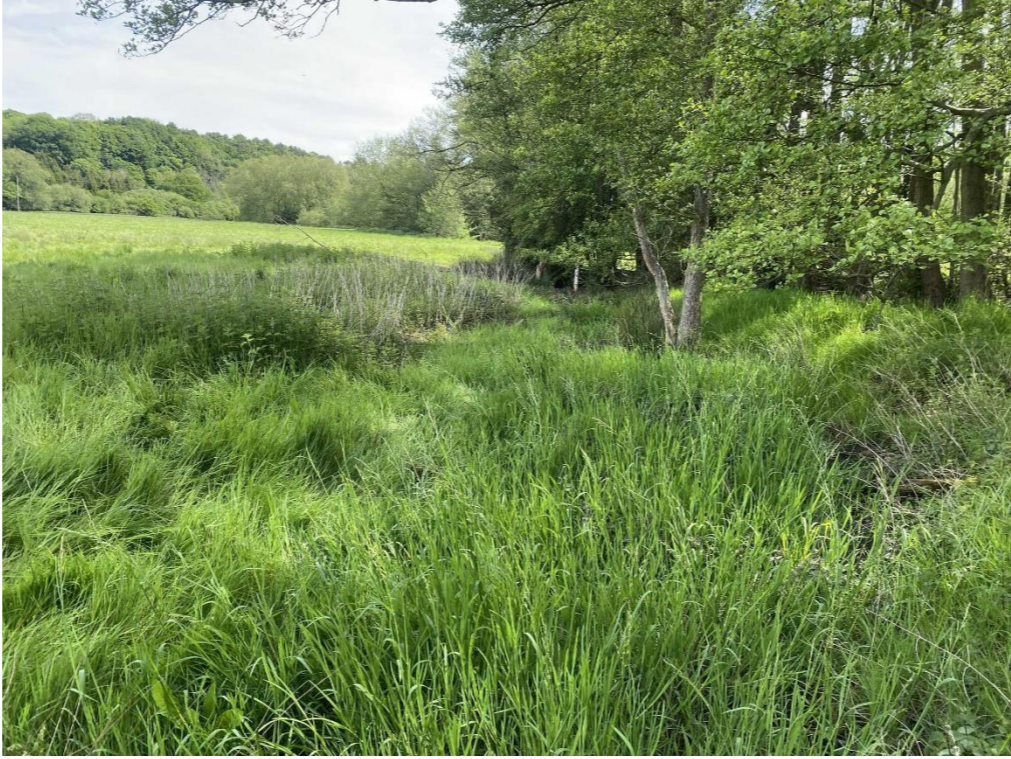
| No. | Description | Photograph(s) |
|---|--|---|
| 19 | Area where water flowing off spring to south-west accumulates behind ditch bank, dominated by <i>Glyceria notata</i> . Stand of <i>Urtica dioica</i> in middle of view is on raised bank above ditch along northern boundary of site. 17/05/2024 | |

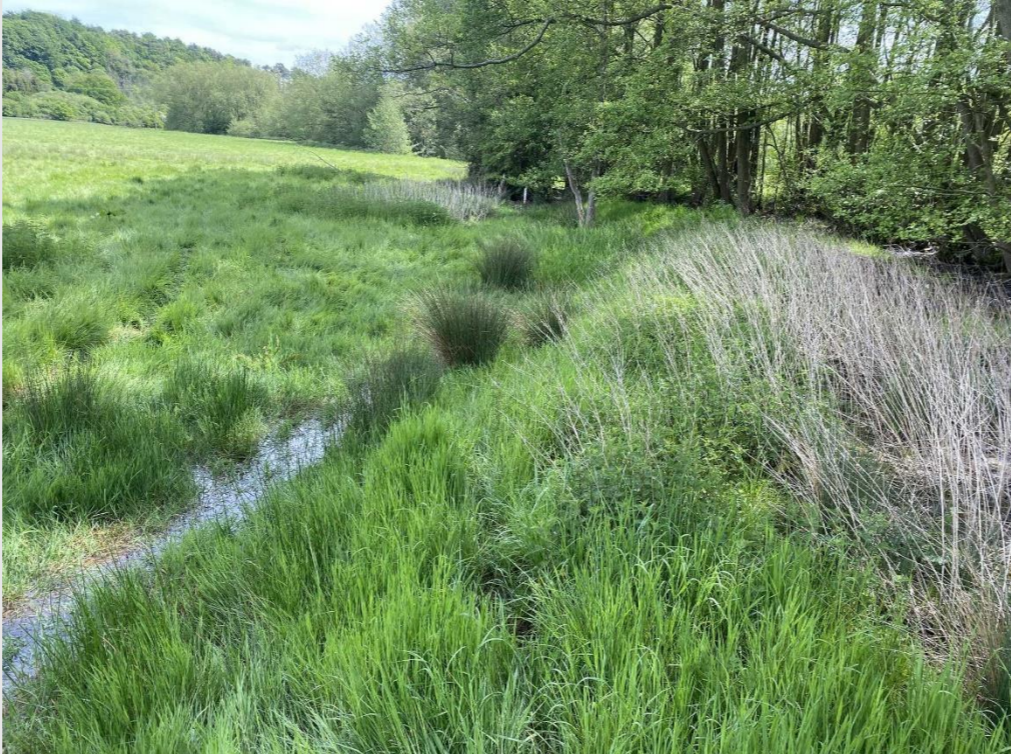
| No. | Description | Photograph(s) |
|---|--|---|
| 20 | View along ditch. Bank to right of image has pipe draining water accumulating above bank into ditch. 17/05/2024 | |

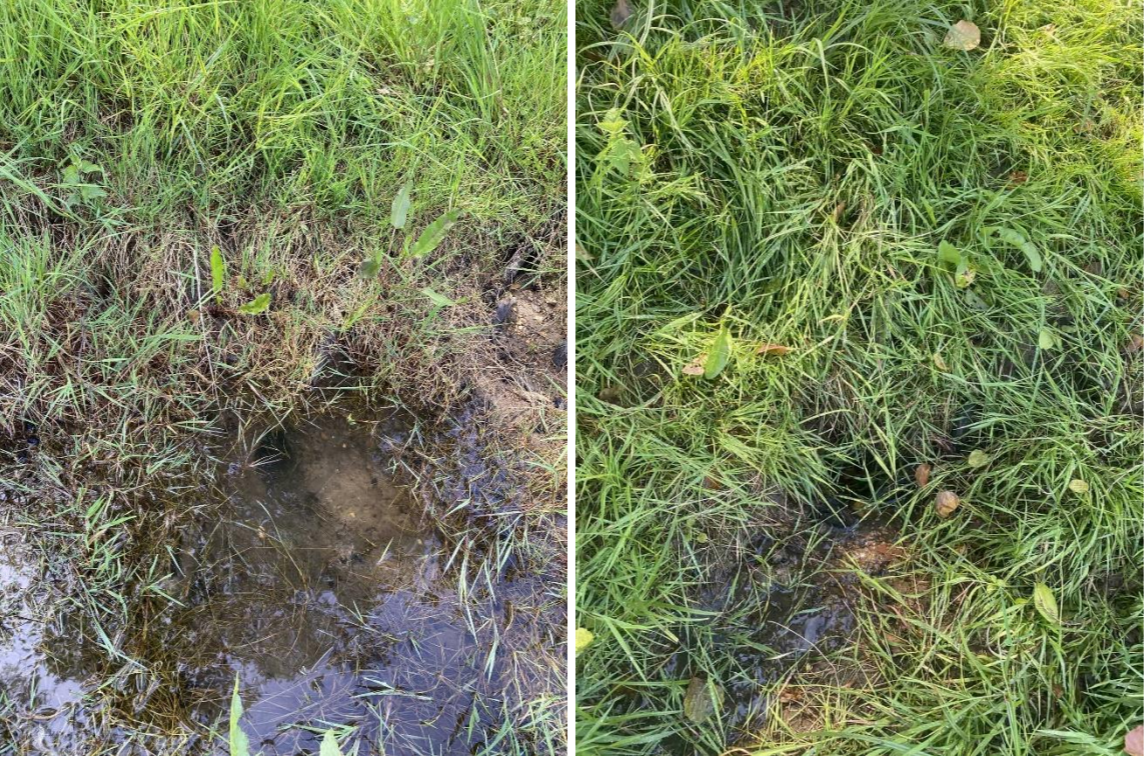
| No. | Description | Photograph(s) |
|---|--|---|
| 21 | Pipe under ditch bank, water seemed to be flowing out of this on 17/05/2024 (left). On 16/08/24 water was draining into it (right). 17/05/2024 | |

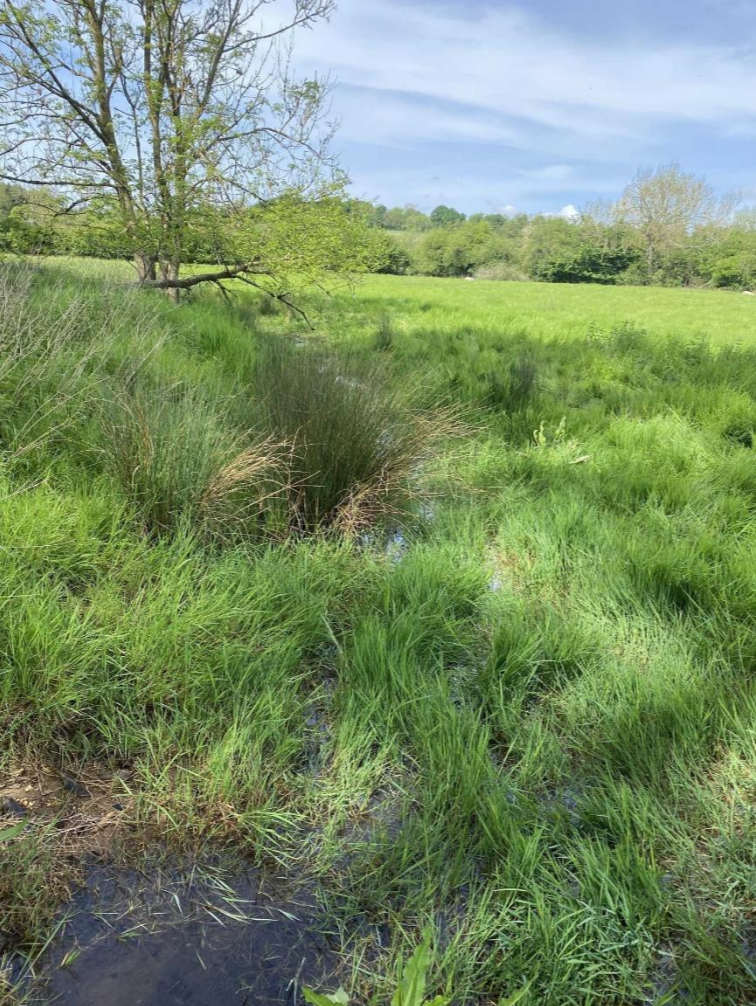
| No. | Description | Photograph(s) |
|---|--|---|
| 22 | Ditch along northern boundary of site, with abundant <i>Glyceria notata</i> . 17/05/2024 | |

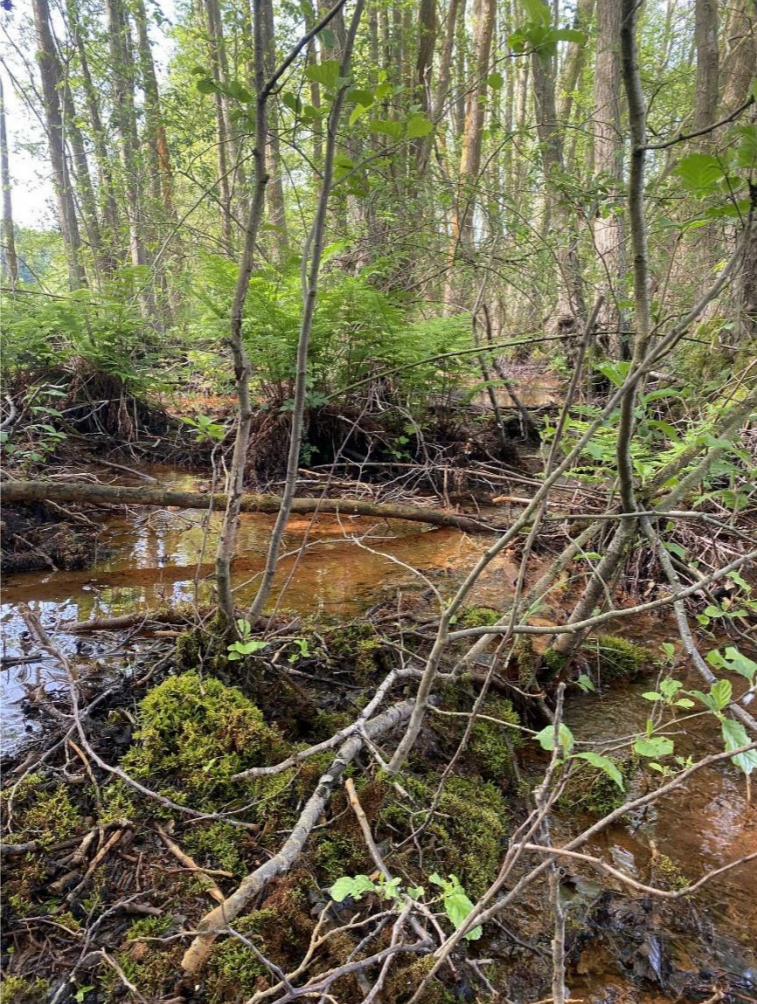
| No. | Description | Photograph(s) |
|---|---|--|
| 23 | Outflow of spring mound, with iron-rich water falling over series of low cascades and pools formed of twigs and <i>Palustriella commutata</i> . 17/05/2024 | |
