Combe Fen Restoration Report

David Morris

Morris, D. 2024. Combe Fen Restoration Report. Freshwater Habitats Trust, Oxford.

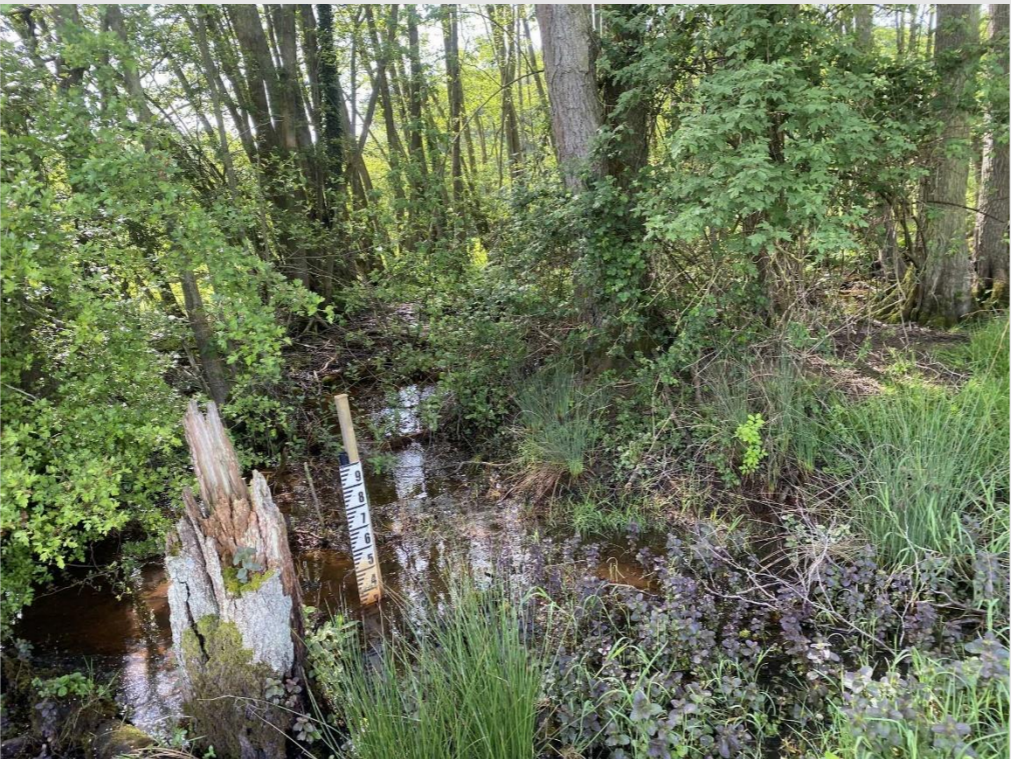
| No. | Description | Photograph(s) |
|---|---|--|
| 24 | Runnel off spring mound, with dipwell and gauge board. Some flow from the western spring mound flows along a channel to this point, from the right of the image. The ditch along the northern boundary of the site also flows to this point. 17/05/2024 | |

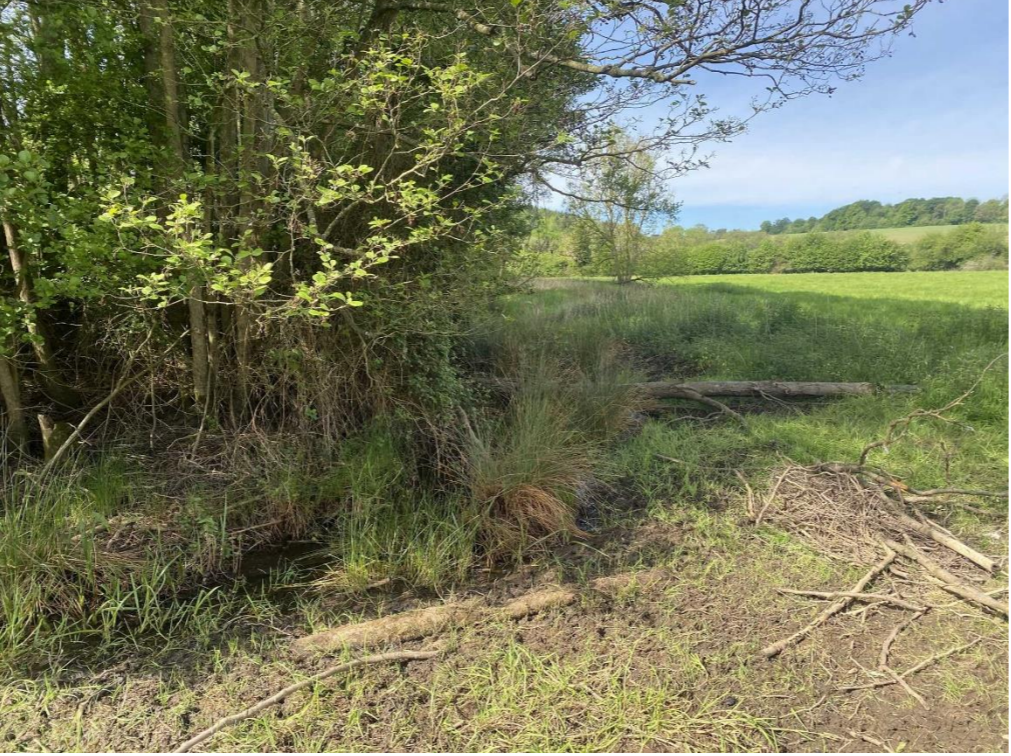
| No. | Description | Photograph(s) |
|---|--|---|
| 25 | Area where boundary ditches meet and drain into pipe to the River Evenlode. 17/05/2024 | |

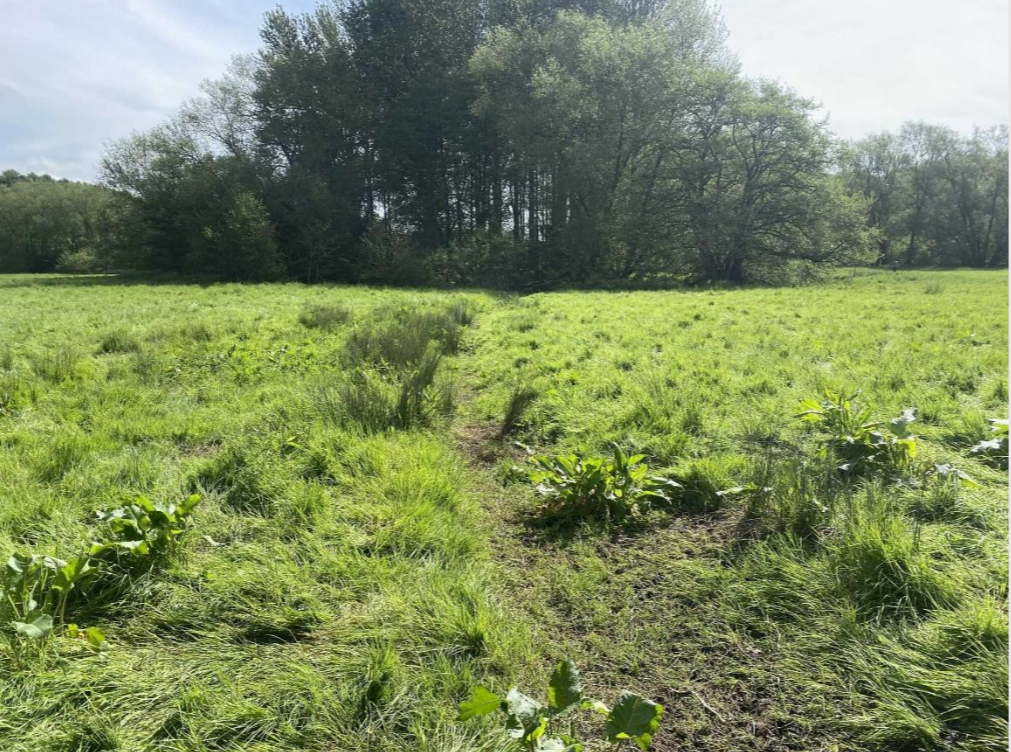
| No. | Description | Photograph(s) |
|---|--|---|
| 26 | View along dry ditch channel toward the River Evenlode. 17/05/2024 | |

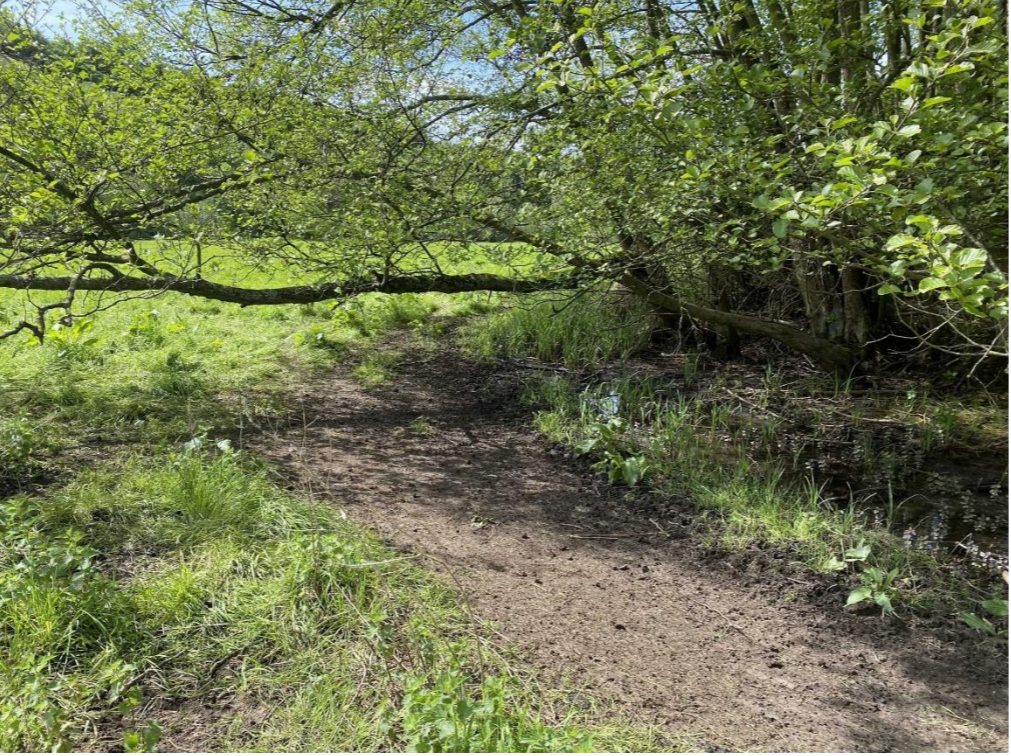
| No. | Description | Photograph(s) |
|---|---|---|
| 27 | Bare ground under trees where sheep shelter. 17/05/2024 | |

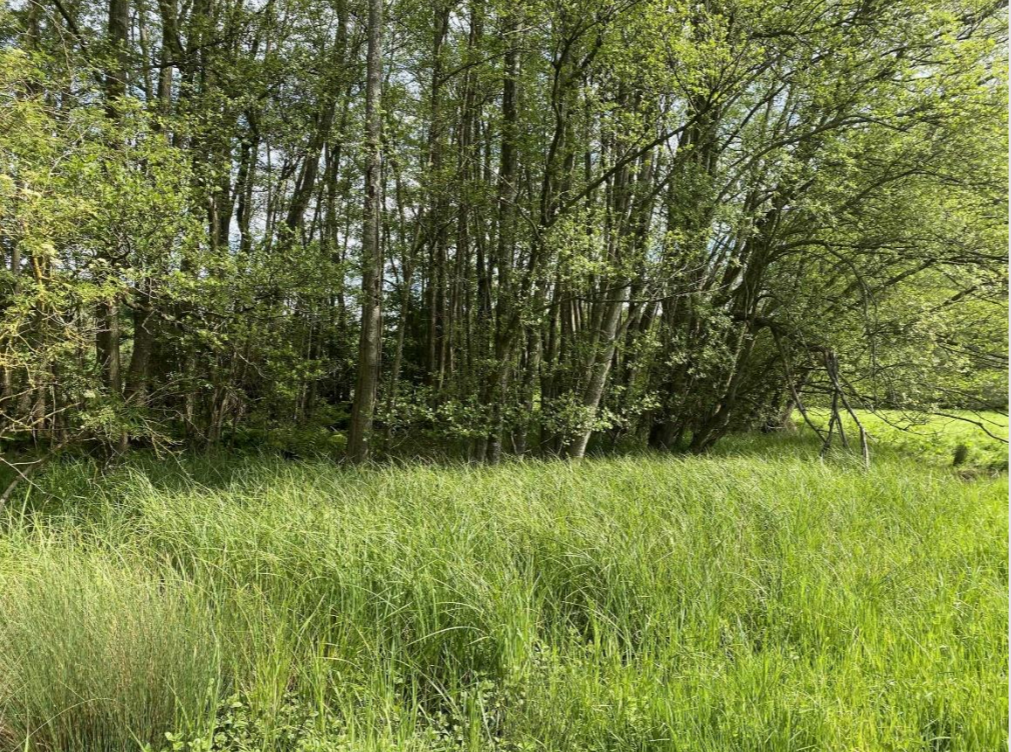
| No. | Description | Photograph(s) |
|---|---|---|
| 28 | Stand of <i>Carex acutiformis</i> extending from ditch into pasture. 17/05/2024 | |

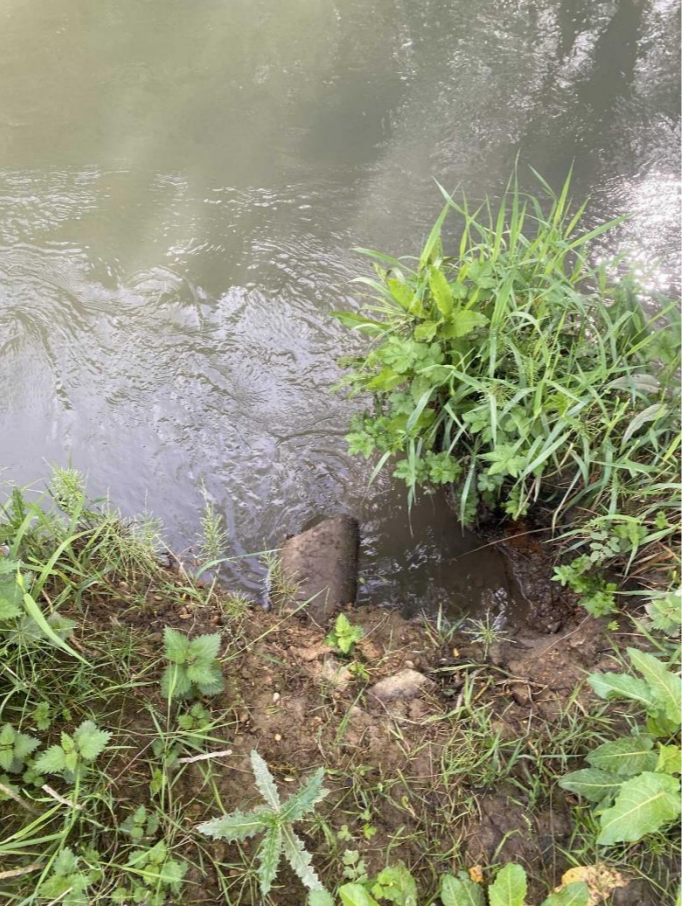
| No. | Description | Photograph(s) |
|---|---|---|
| 31 | Pipe discharging flow from site into River Evenlode. 17/05/2024 | |

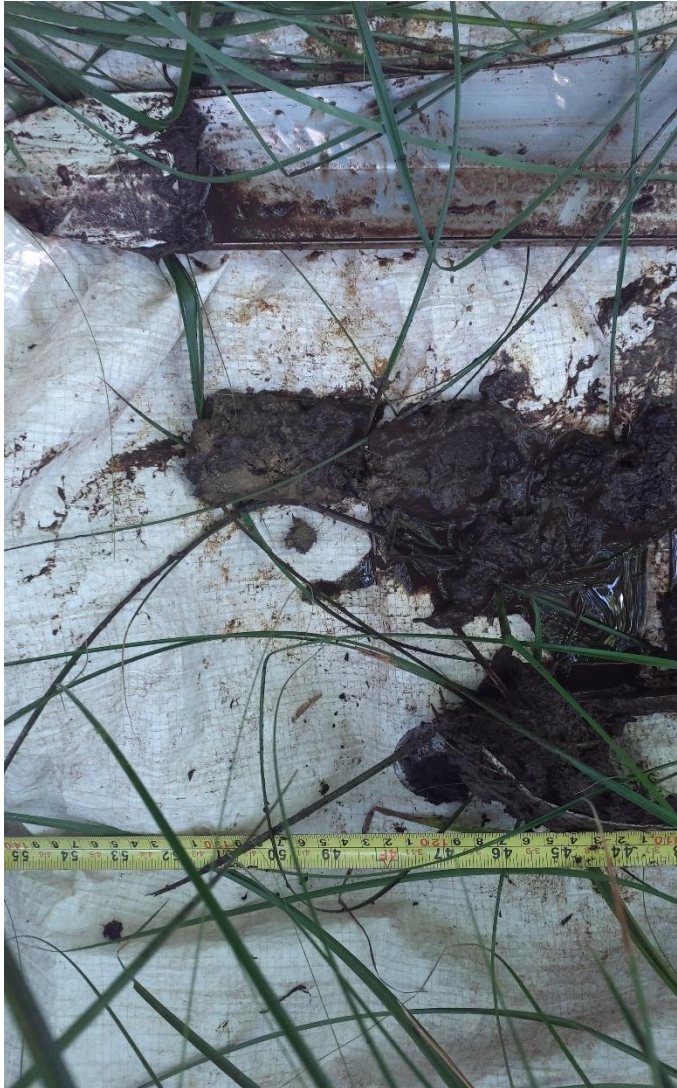
C3
Photo.
no.
5

Photo. (top of core to right)

Peat from the core in the western spring mound (C3) consisted of a weakly decomposed upper portion to 0.56 mbgl, and a fluid, almost completely decomposed lower portion, to 1.2 mbgl. The latter was similar to the loose organic deposit in the zone of groundwater discharge within the spring mound (see Figure 5) and is presumably continuous with it.
