Water Friendly Farming Case Study – lessons learnt

Optimising leaky barriers to prevent collapse and improve performance

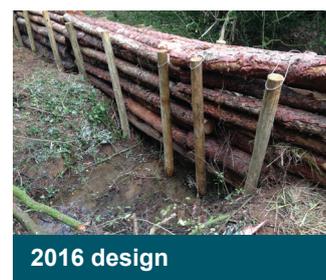
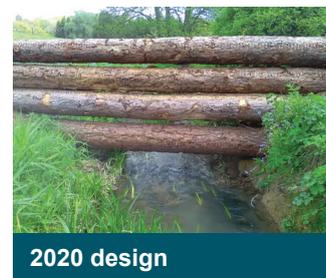
2016 design

2020 design

Fig 1. The design of our leaky barriers has changed significantly to improve their stability and flood performance

Over the years, the design of Water Friendly Farming’s leaky barriers has changed significantly to increase barrier stability and function (Fig 1). Modifications have been based on: (i) modelling the changing flood performance of the barriers as they settled in, and (ii) measurement and observations of collapsed or degrading barriers in Water Friendly Farming and other projects.

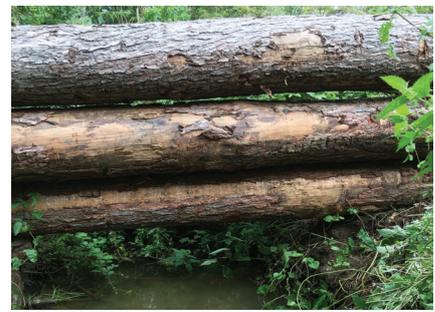
Fig 2. Larger gaps below and between the leaky barrier logs are designed to ensure they rapidly drain away flow from preceding rain events creating greater storage capacity for large floods

For this reason, the most recent Water Friendly Farming barriers (constructed in 2020) have: (i) a larger bottom flow gap and (ii) spacing between logs to create greater storage capacity for the largest floods (Fig 2). Note that adding a gap between the cordwood is an experimental approach, and the ideal gap between logs, and how well these barriers function in practice, is the subject of investigation.

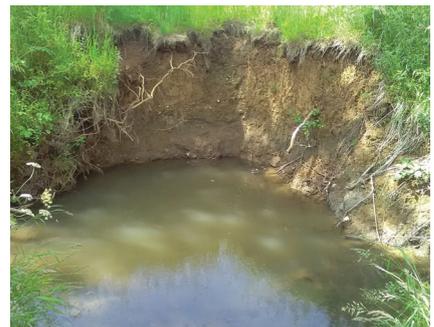
Fig 3. Lateral bank scour created by a collapsed leaky barrier (now removed)

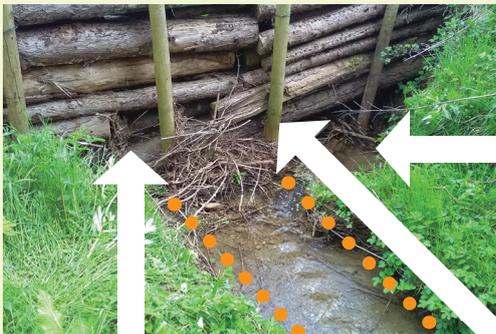
Old design: a five year old barrier with considerable bank erosion and partial collapse

- (i) base of the barrier is too low and traps brush which blocks the stream, forcing it sideways and causing lateral scour of the bank. Vertical posts in the channel also trap brush
- (ii) the bottom log is not embedded deeply enough into the bank, and has been undermined by lateral bank scour
- (iii) other logs do not span the whole channel and rest on each other making the whole barrier unstable
- (iv) the structure has low permeability: this increases water pressure against the dam's upstream face, and hence its potential to fail in flood

Bottom log has fallen into the channel upstream of the barrier because the bank into which it was embedded has been eroded. The log now blocks normal flows

Stream has eroded into bank to find an alternative route around the brush

Vertical posts and a low bottom log means that brush is trapped upstream of the barrier

● ● ● ● ● ● ● ●
ORIGINAL CHANNEL

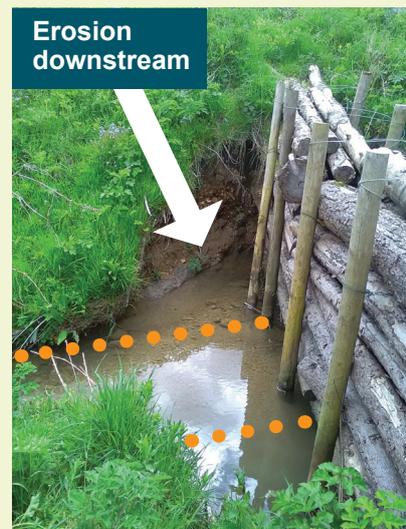
Erosion downstream

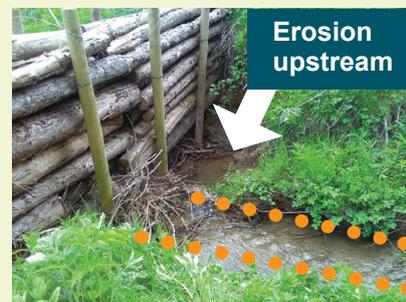
Erosion upstream

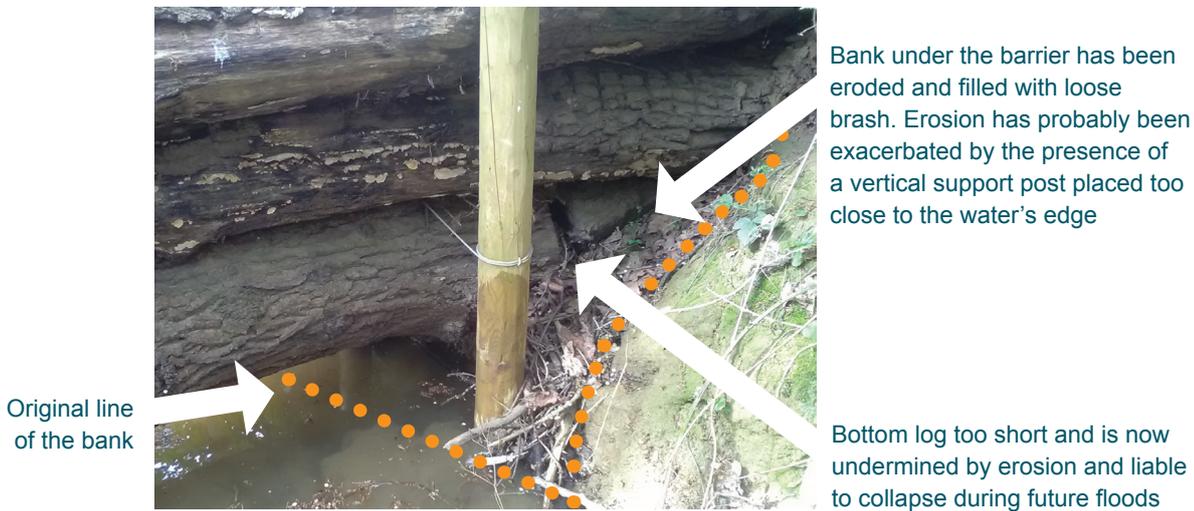
Fig 6. Bank erosion / embayment

Typical advice is that that cordwood should be 1.5 times the width of the channel. However, this may be insufficient, particularly where bank substrates are soft or the erosive power of the stream in flood is high.

Current advice from Countryside Stewardship¹ says that a barrier's lowest logs should extend 0.5 m into the bank. Other guides recommend that logs should be 1.5 to 2.5 times the width of the channel.^{2,5} Our evidence shows that, in areas of soft rock geology, bank scour can erode well over 1 m into the bank within just a few years and that this erosion is a critical factor that reduces barrier stability. To address this we now ensure that, even on the smallest small streams and ditches, the lowest log always extends at least 1m into the bank. Where there is higher erosive potential (i.e. bank substrates are soft, or the stream is large, gradients are steep and currents are stronger), then cordwood may be embedded 2 m or more into each bank (Fig 6). Long lengths of cordwood can be expensive, and will often need to be imported from off-site. However, our experience is that it is a more cost-effective option in the long run.

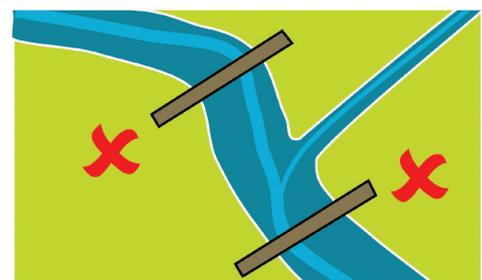
Fig 8. Avoid locating dams either on bends or below inflows: where scour (pale blue line) is likely to become focussed close to one bank

It is preferable to locate barriers on straight sections of stream, rather than close to bends where erosional and depositional processes are already more active and the thalweg (deepest point in the river and main line of erosion) lies close to the outer bank causing enhanced erosion here.

Likewise, locating barriers just below the confluence of two streams, or below where a large floodwater ditch enters a stream, is risky because confluences are naturally areas of high scour, and barriers located here are more likely to suffer end erosion.

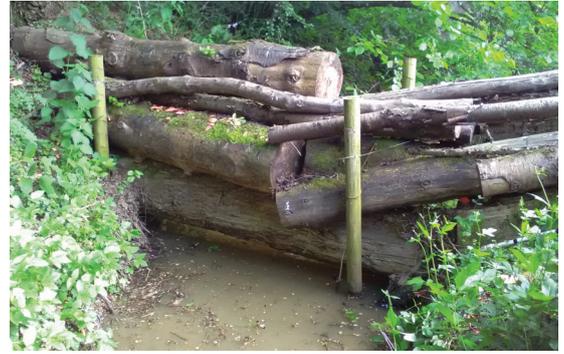
Fig 9. Bottom log partially collapsed and logs above now fallen or unstable

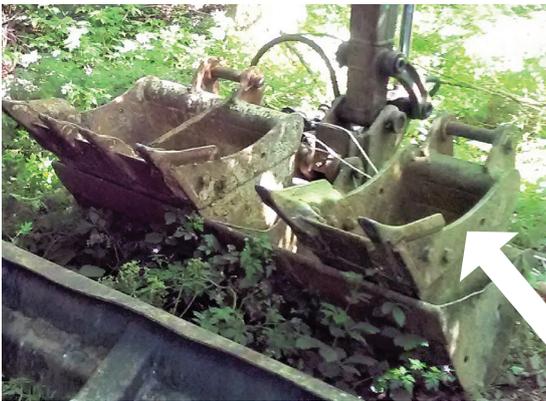
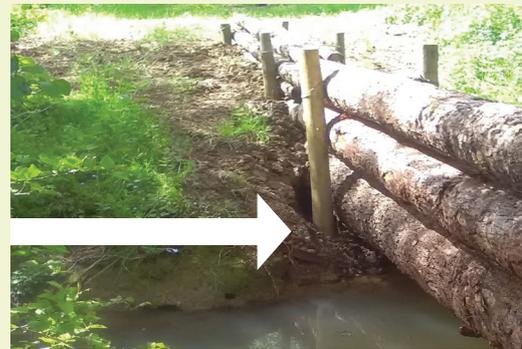
Using a narrow bucket allows logs to be slotted into their trench with minimal bank disturbance

Fig 10. Minimising disturbance around the barrier

New barrier, two weeks after construction

- The bank could have been excavated so as to slot in the logs with less spoil removed
- Remaining gaps should have been back-filled to the original bank profile and thoroughly tamped down to minimise opportunities for erosion

Dig a *narrow* trench to slot logs into place rather than over-digging and back-filling the bank around the logs. This retains as much undisturbed soil, roots and vegetation around the barrier as possible, reducing the potential for bank erosion. Where soil is disturbed, tamp it down hard when back-filling around the barrier.

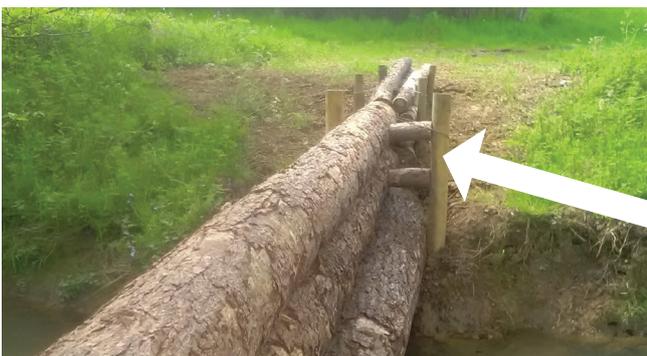
Horizontal batons are needed here to brace the upper logs against the vertical support post because the lowest log is wider than those above. This is not an optimal solution and it is not clear how well the batons will persist in the longer term.

Fig 11. Measures needed to brace logs of uneven width

Ideally, cordwood lengths used to create the barrier should have similar diameter. Our logs are not pinned together and uneven-width logs are difficult to brace against the vertical support posts, so it is likely that logs will be more easily wrenched out of their bed under the pressure of floodwater.
